# Farabaugh Engineering and Testing Inc.

Project No. T330-11

TAS 100-95 TEST PROCEDURE FOR WIND AND WIND DRIVEN RAIN RESISTANCE OF DISCONTINUOUS ROOF SYSTEMS PERFORMANCE TEST REPORT

> PANEL-LOC PLUS ROOF PANEL 36" WIDE X 29 GA. STEEL

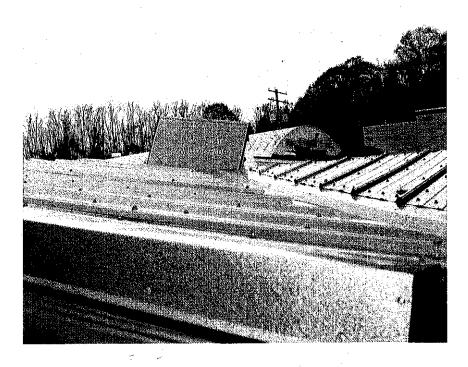
TOPSIDE OF ASSEMBLY PRIOR TO TEST

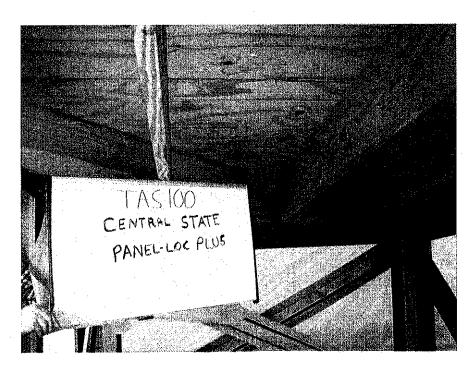
UNDERSIDE OF ASSEMBLY PRIOR TO TEST

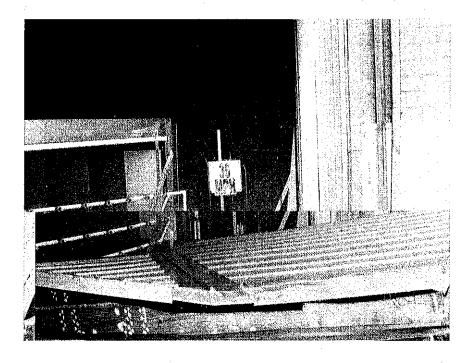
**TOPSIDE OF ASSEMBLY AT 35 MPH**

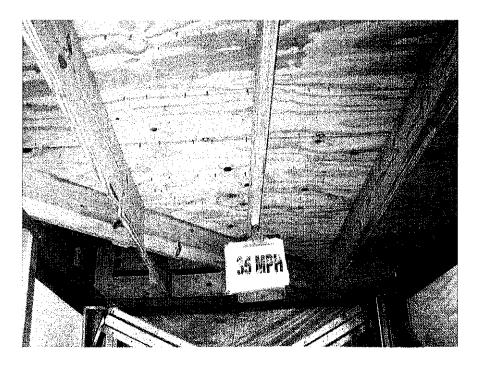
**UNDERSIDE OF ASSEMBLY AT 35 MPH**

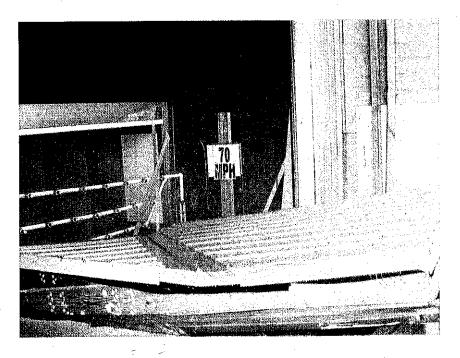
TOPSIDE OF ASSEMBLY AT 70 MPH

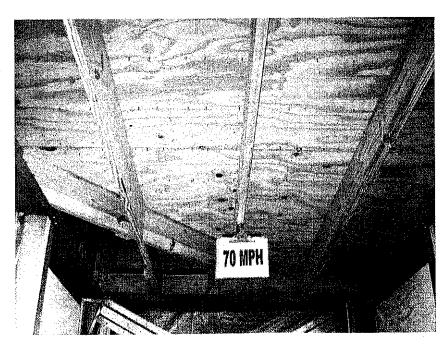
UNDERSIDE OF ASSEMBLY AT 70 MPH

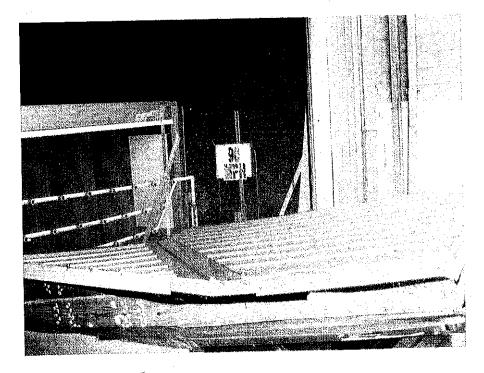
TOPSIDE OF ASSEMBLY AT 90 MPH

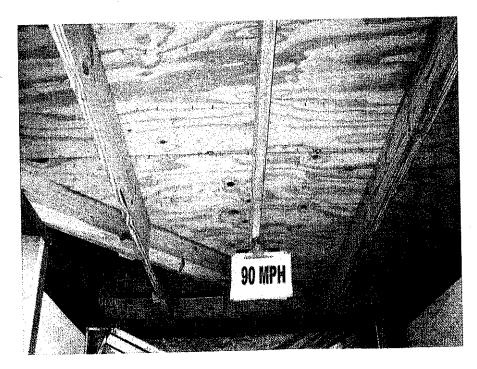
UNDERSIDE OF ASSEMBLY AT 90 MPH

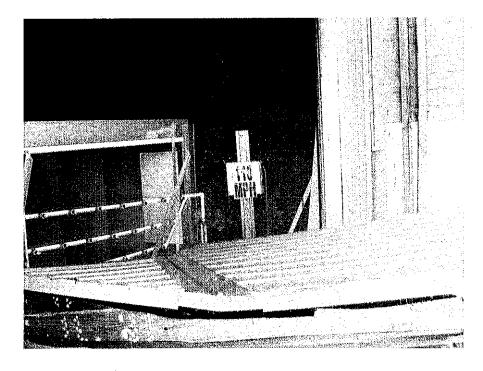
TOPSIDE OF ASSEMBLY AT 110 MPH

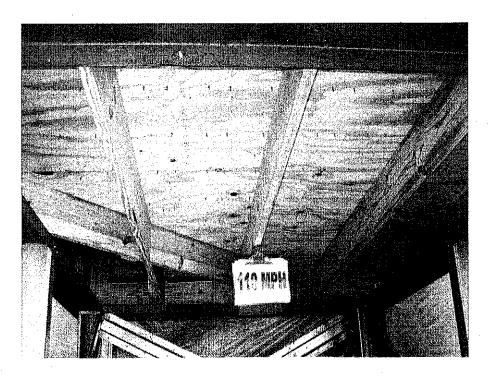
UNDERSIDE OF ASSEMBLY AT 110 MPH

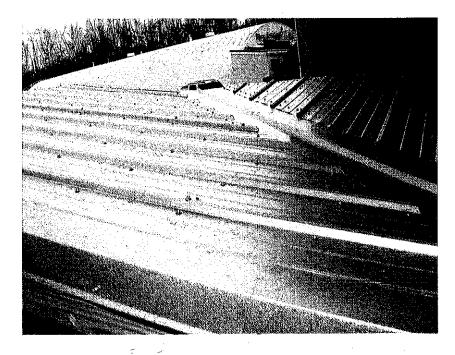
Upon completion of the test intervals, visual observation indicated that there was no damage to the roof system and no water infiltration on the underside of the sheathing.

TOPSIDE OF ASSEMBLY AFTER TESTING

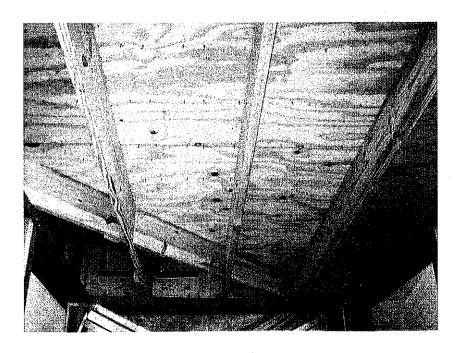
UNDERSIDE OF ASSEMBLY AFTER TESTING
